DDASaccident460

DDAS Accident Report

Report date: 04/01/2008	Accident number: 460
Accident time: 08:21	Accident Date: 16/09/2004
Where it occurred: MF ID 11290, Odmutsko Polje 1 - Grebnice, Domaljevac-Samac	Country: Bosnia Herzegovina
Primary cause: Management/control inadequacy (?)	Secondary cause: Field control inadequacy (?)
Class: Excavation accident	Date of main report: 05/10/2004
ID original source: None	Name of source: BHMAL WL
Organisation: [Name removed]	
Mine/device: PROM-1 AP Bfrag	Ground condition: leaf litter metal scrap wet woodland (bush)
Date record created: 04/01/2008	Date last modified: 04/01/2008
No of victims: 2	No of documents: 1

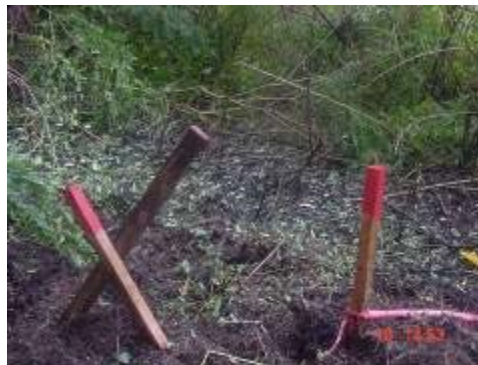
[Accident site (crater in centre).]

The area around the accident has been disturbed after the accident and some pegs and tapes were obviously placed after the accident.

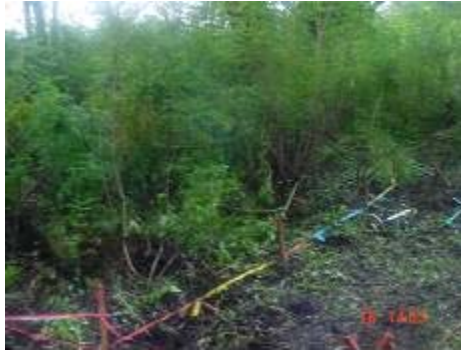
The work-site had not been established according to the National Standards of Bosnia and Herzegovina and the SOPs. The administrative areas were established on the safe distance, but the area was not properly marked.

[Vegetation at the site.]
